MARINE INVESTIGATION REPORT

M99M0062

GROUNDING

MOTOR POWERED SAILING VESSEL "BLUENOSE II"

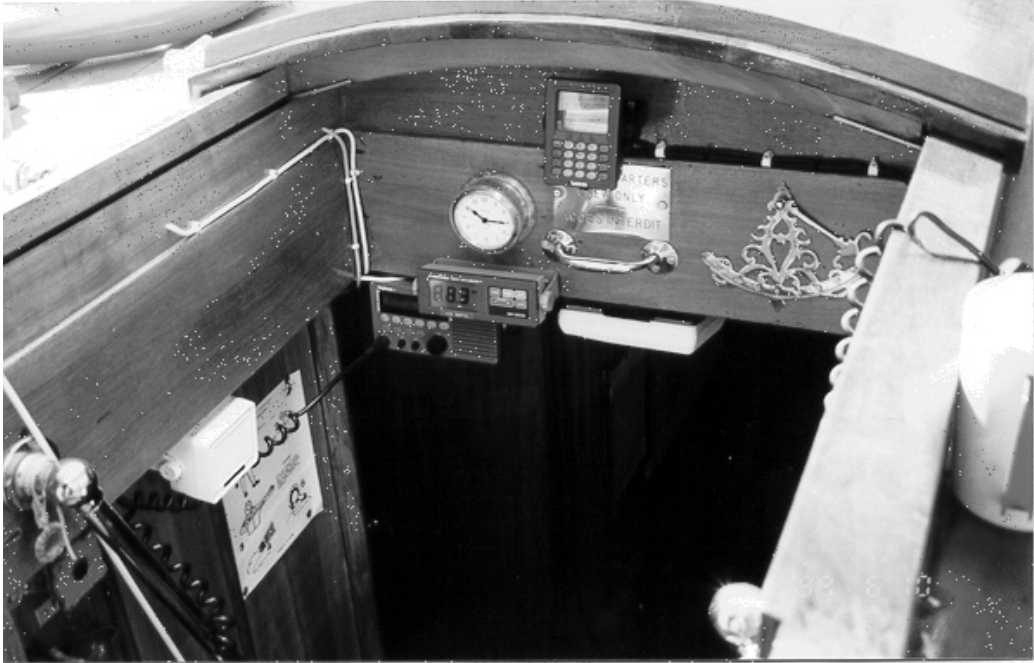
It was believed that the echo sounder transducer was positioned 10 feet above the keel but it was later determined that this distance was 3 feet. At the time of the occurrence, 10 feet was added to the reading indicated on the echo sounder repeater, to obtain the depth of water.

It appears that the echo sounder repeater readout was intermittent and known to be so. The value of the readout was also compromised by the fact that the master and officers believed that instrument's transducer was 10 feet above the keel when it was, in fact, 3 feet above the keel. As a result of a miscalculation, the master believed that the water was 7 feet deeper than it was. In addition, the echo sounder indicated depths in feet and the Halifax harbour chart indicated them in metres.

7. The sounding machine repeater occasionally did not exhibit a reading although a reading was available on the main unit in the chart room.
8. The master and officers believed that the echo sounder transducer was 10 feet above the keel, when in fact it was 3 feet above the keel. As a result of a miscalculation, the master believed that the water was 7 feet deeper than it was.

9. The sounding machine and its repeaters showed depths of water in feet, while the chart of Halifax harbour indicated soundings in metres. The conversion necessary to assimilate echo sounder information caused some confusion.

Depth sounder repeater (under clock), with taped instructions to add 10 (feet). Soundings indicated in feet.

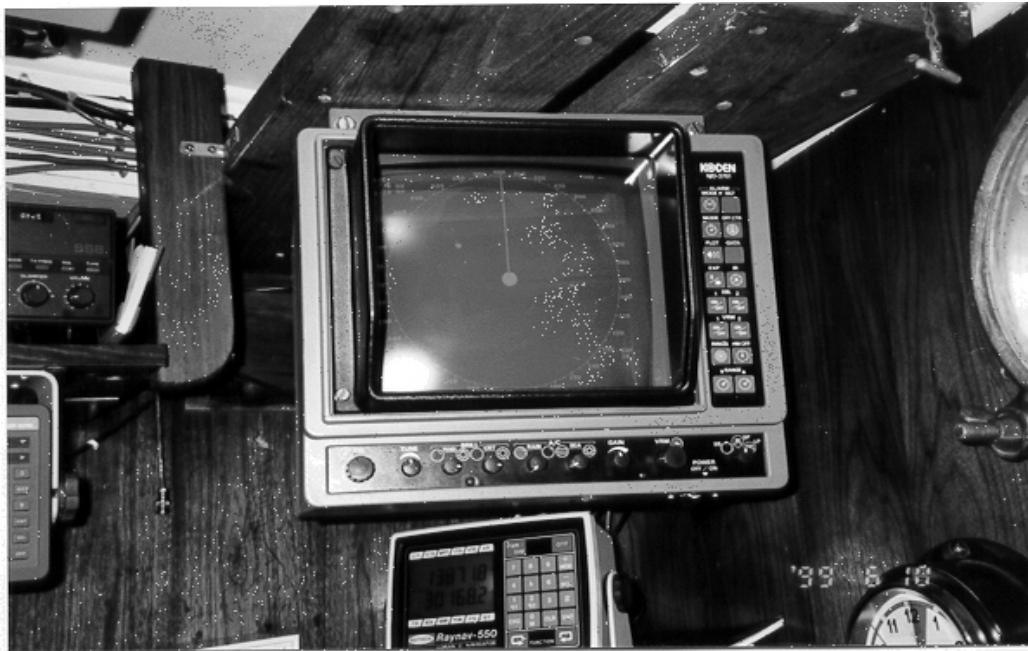
The location of the navigational equipment in the chart room was not optimal. As a result, positional information displayed on the radar, electronic chart, and GPS, which could have indicated that the vessel was standing into danger on Pleasant Shoal, was not visible from the conning position and not available to the master.

6. Most of the aids to navigation, radar, electronic chart and GPS were placed in the chart room such that they were not visible to a person in the conning position.

Radar display in the chart room—not visible from the conning position

Prior to departing a berth with passengers on board, a safety announcement is made and the correct method of donning a life jacket demonstrated. Other safety equipment is explained, such as inflatable life rafts. A tally of the number of passengers is given to the master prior to departure. When the vessel is underway, an officer is now positioned in the chartroom to watch the electronic chart display, radar, etc., and to provide navigational information from these sources to the master at the conning position on deck.

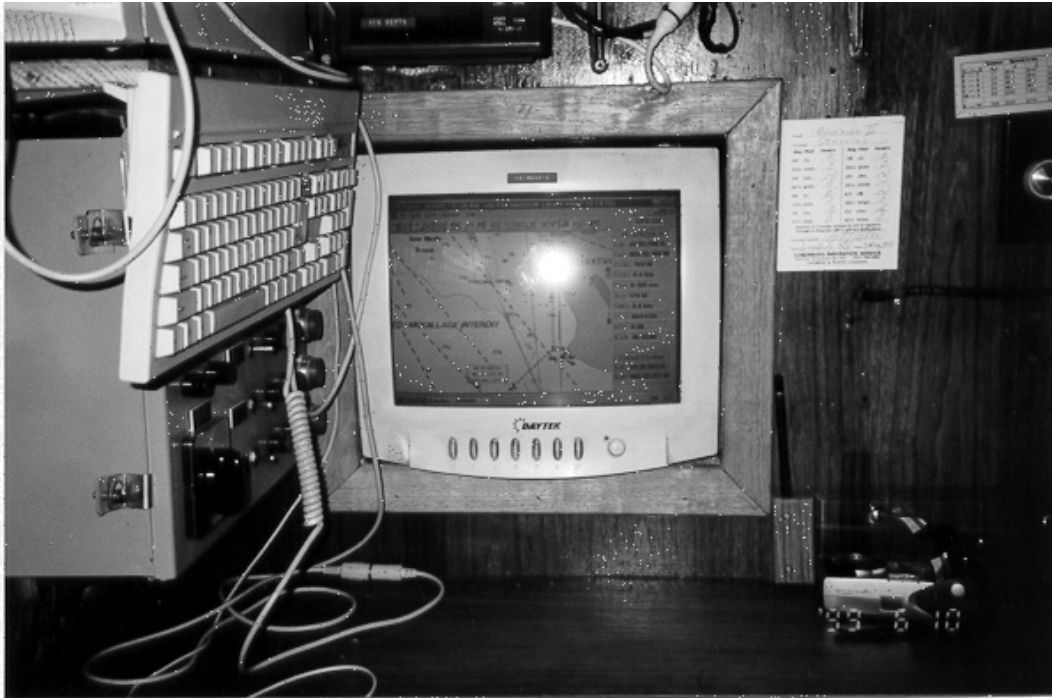
Electronic chart display—not visible from the conning position
